# Long term monitoring of restoration projects is crucial for recognizing successes, identifying and fixing problems, and tracking continuing threats

## The dune separating Cove Point Marsh from the Chesapeake Bay was breached in 2007.

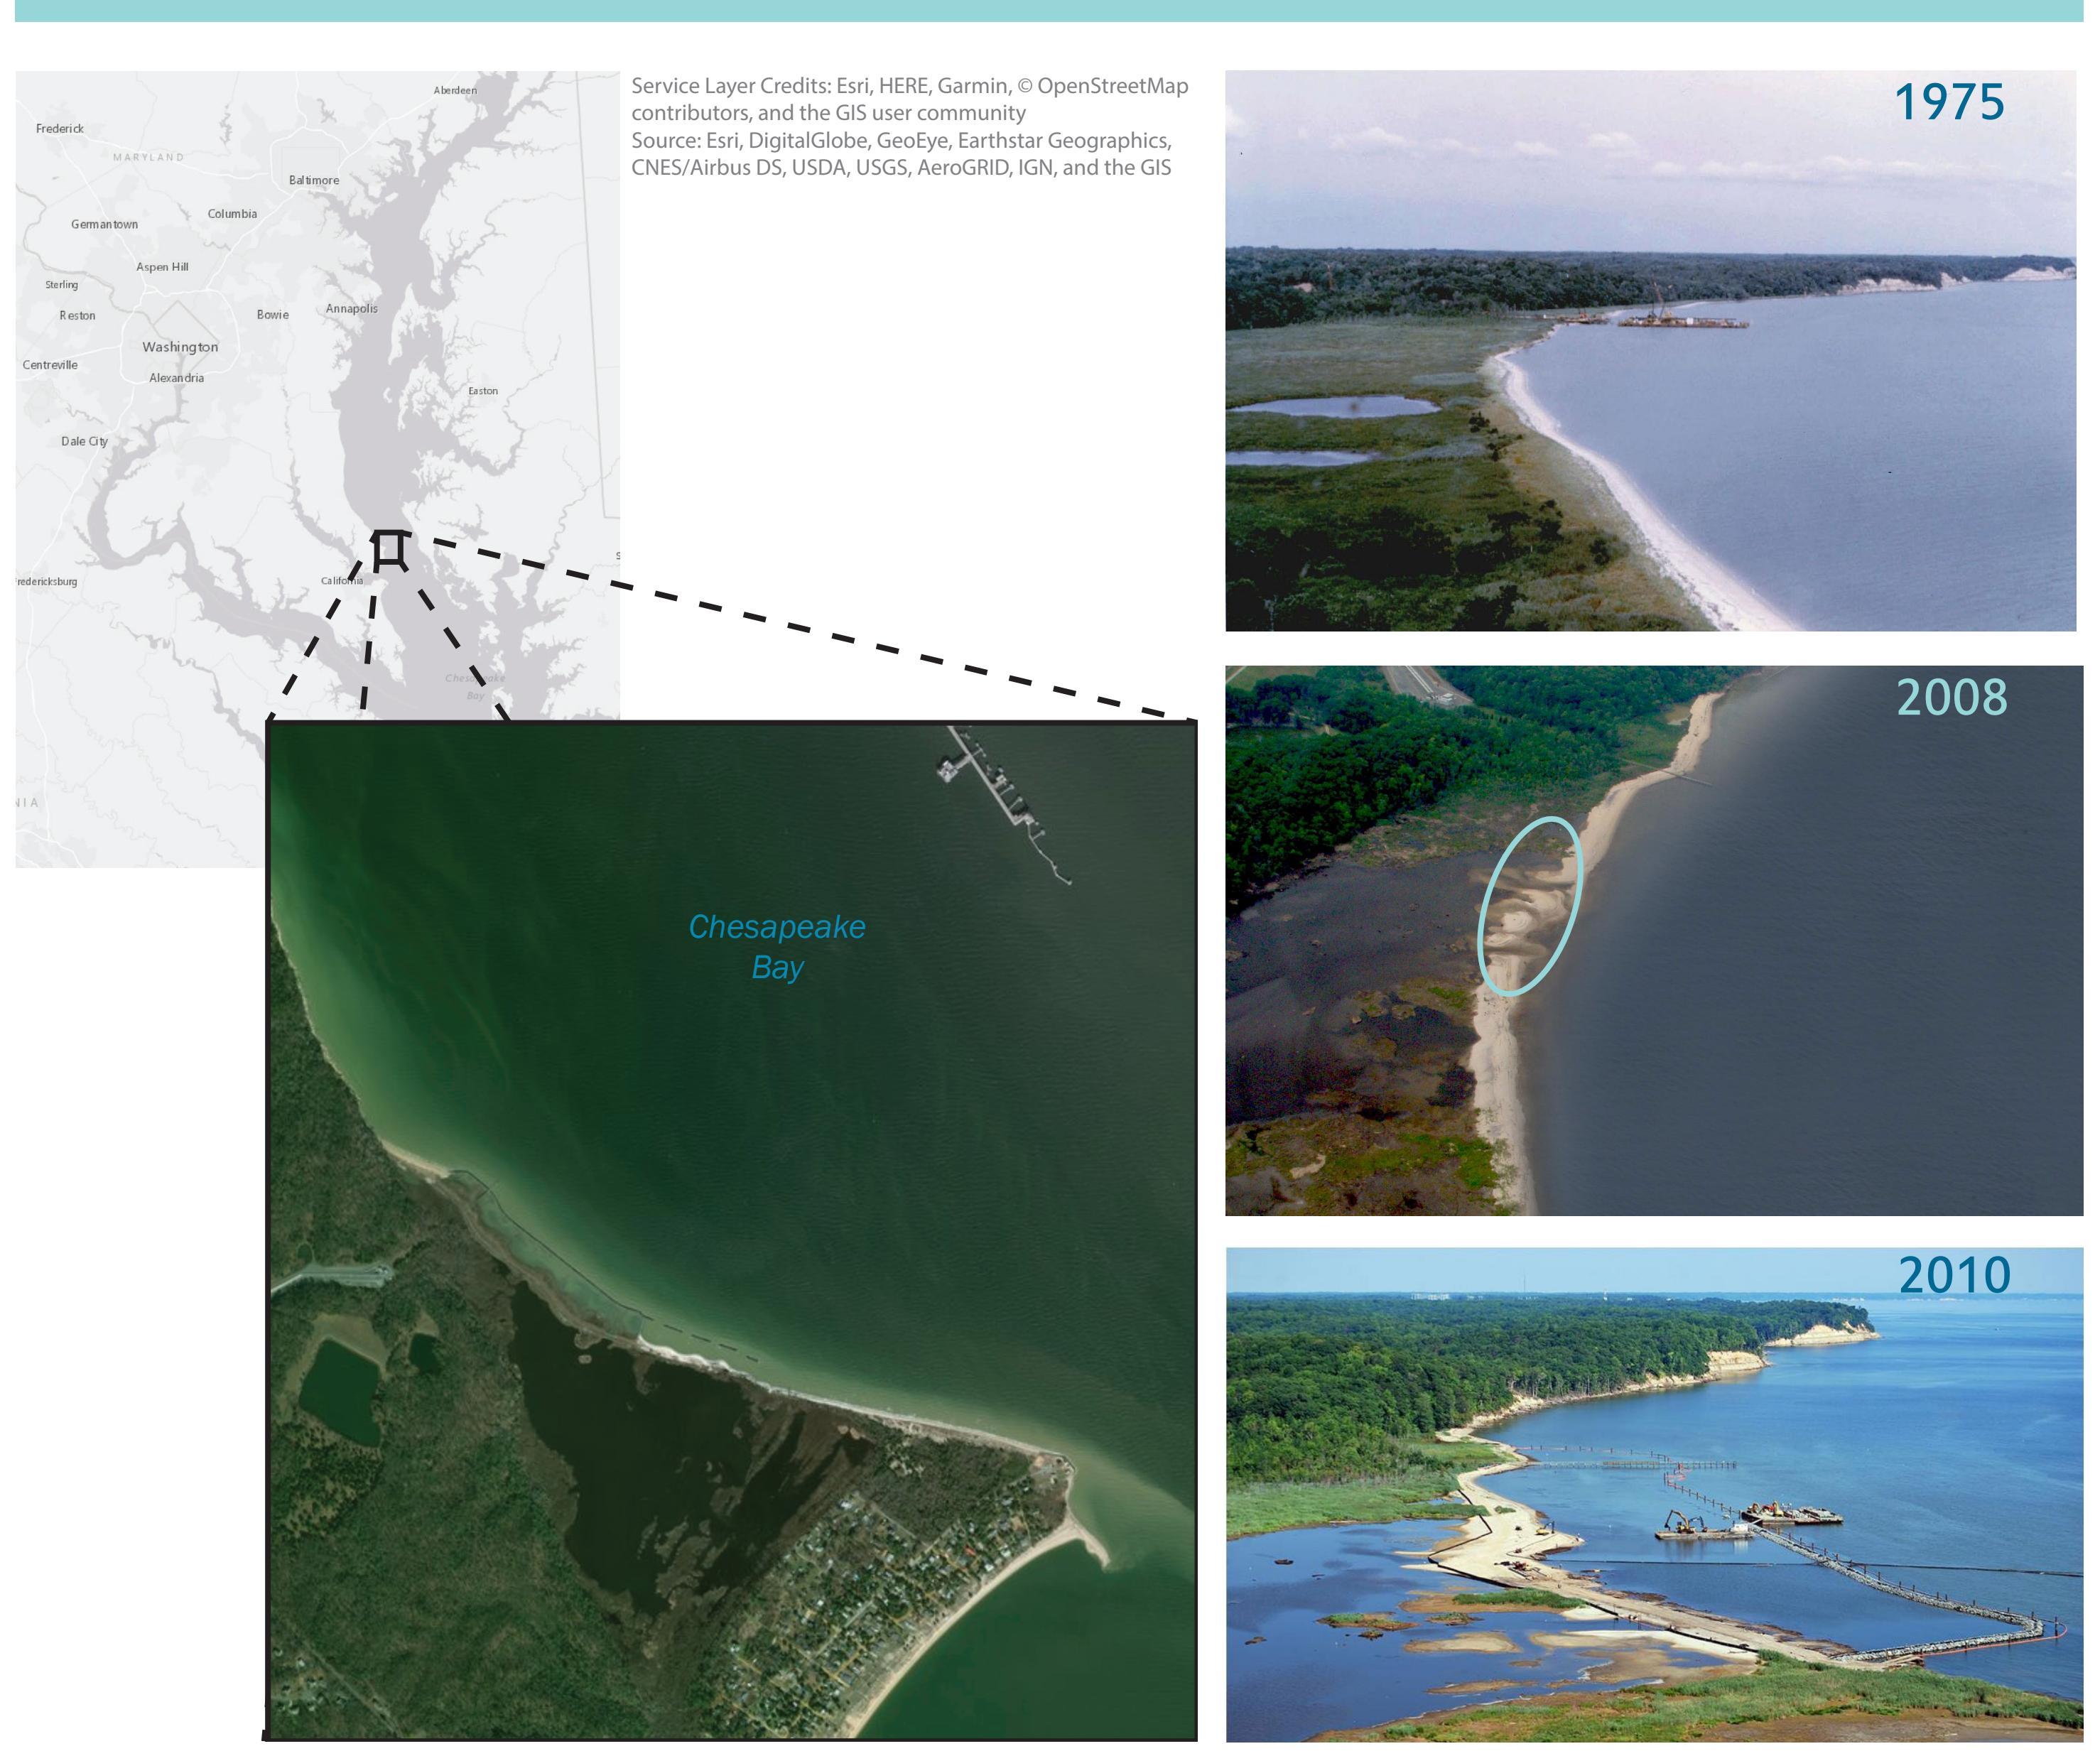
Map of the Chesapeake Bay showing the location of Cove Point Marsh. Aerial images show the site pre-breach in 1975, in 2008 with the breaches in the dune circled in blue, and during construction in 2010.

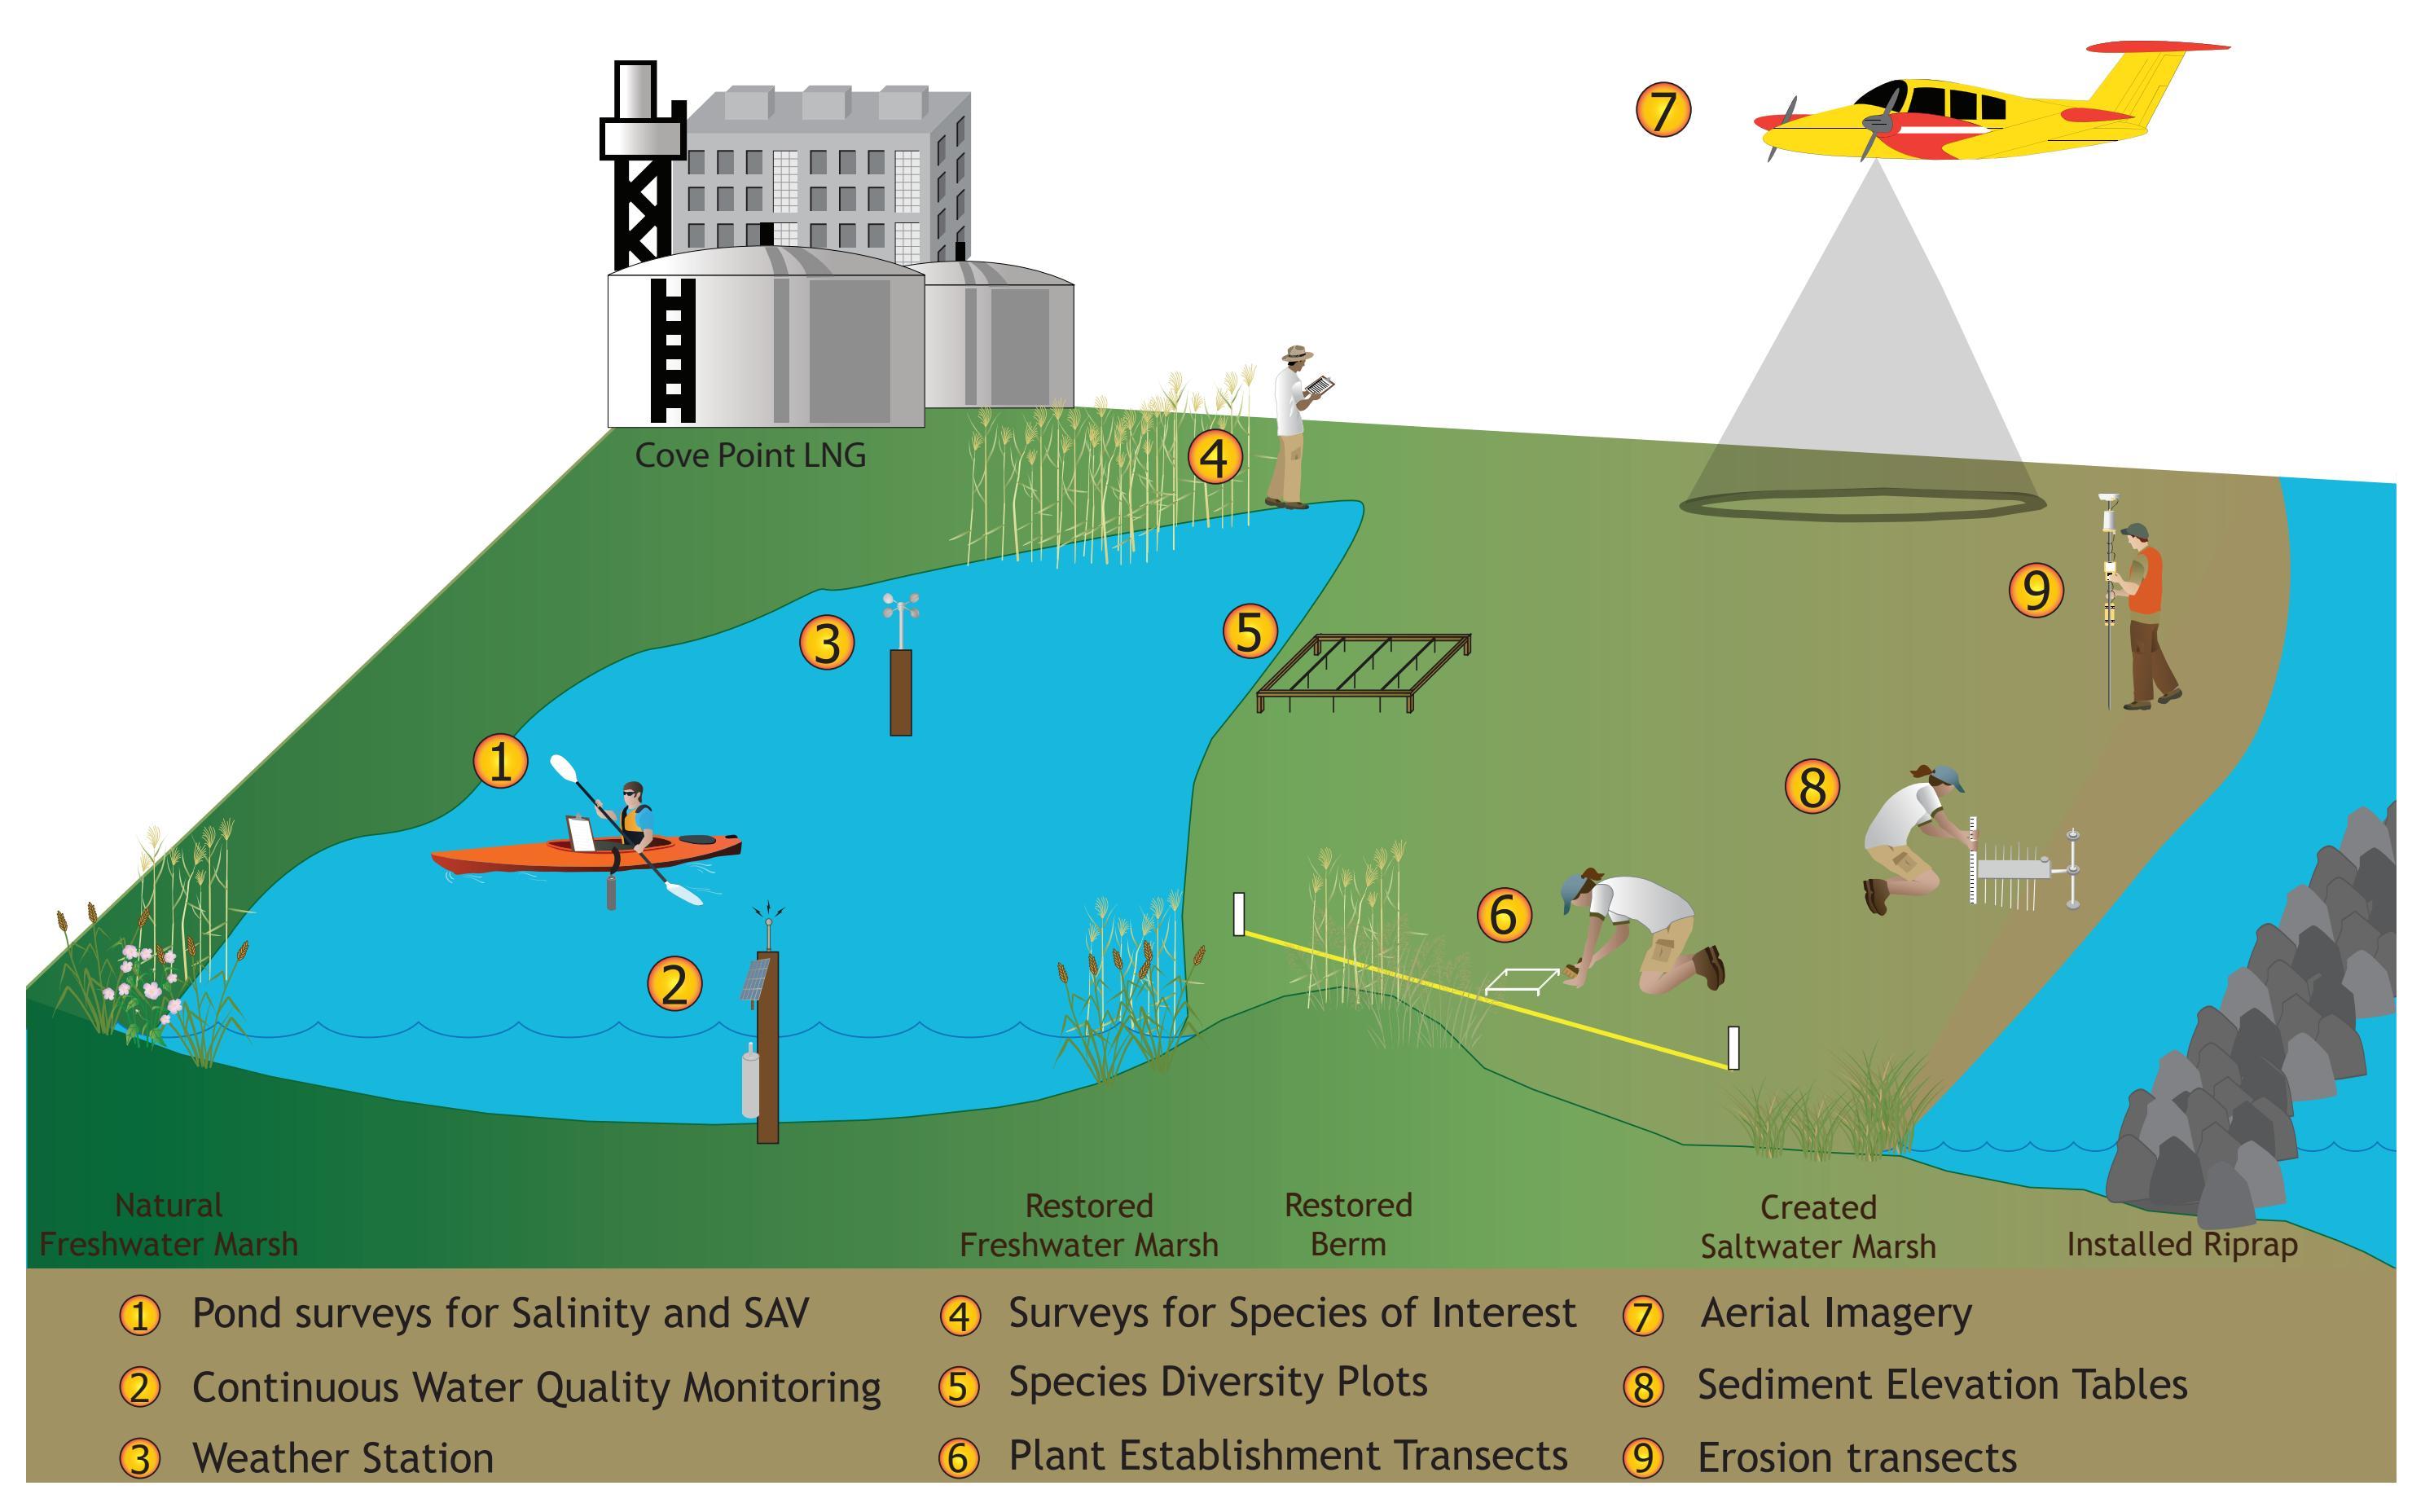
Conceptual Diagram describing the parts of the Monitoring Plan.

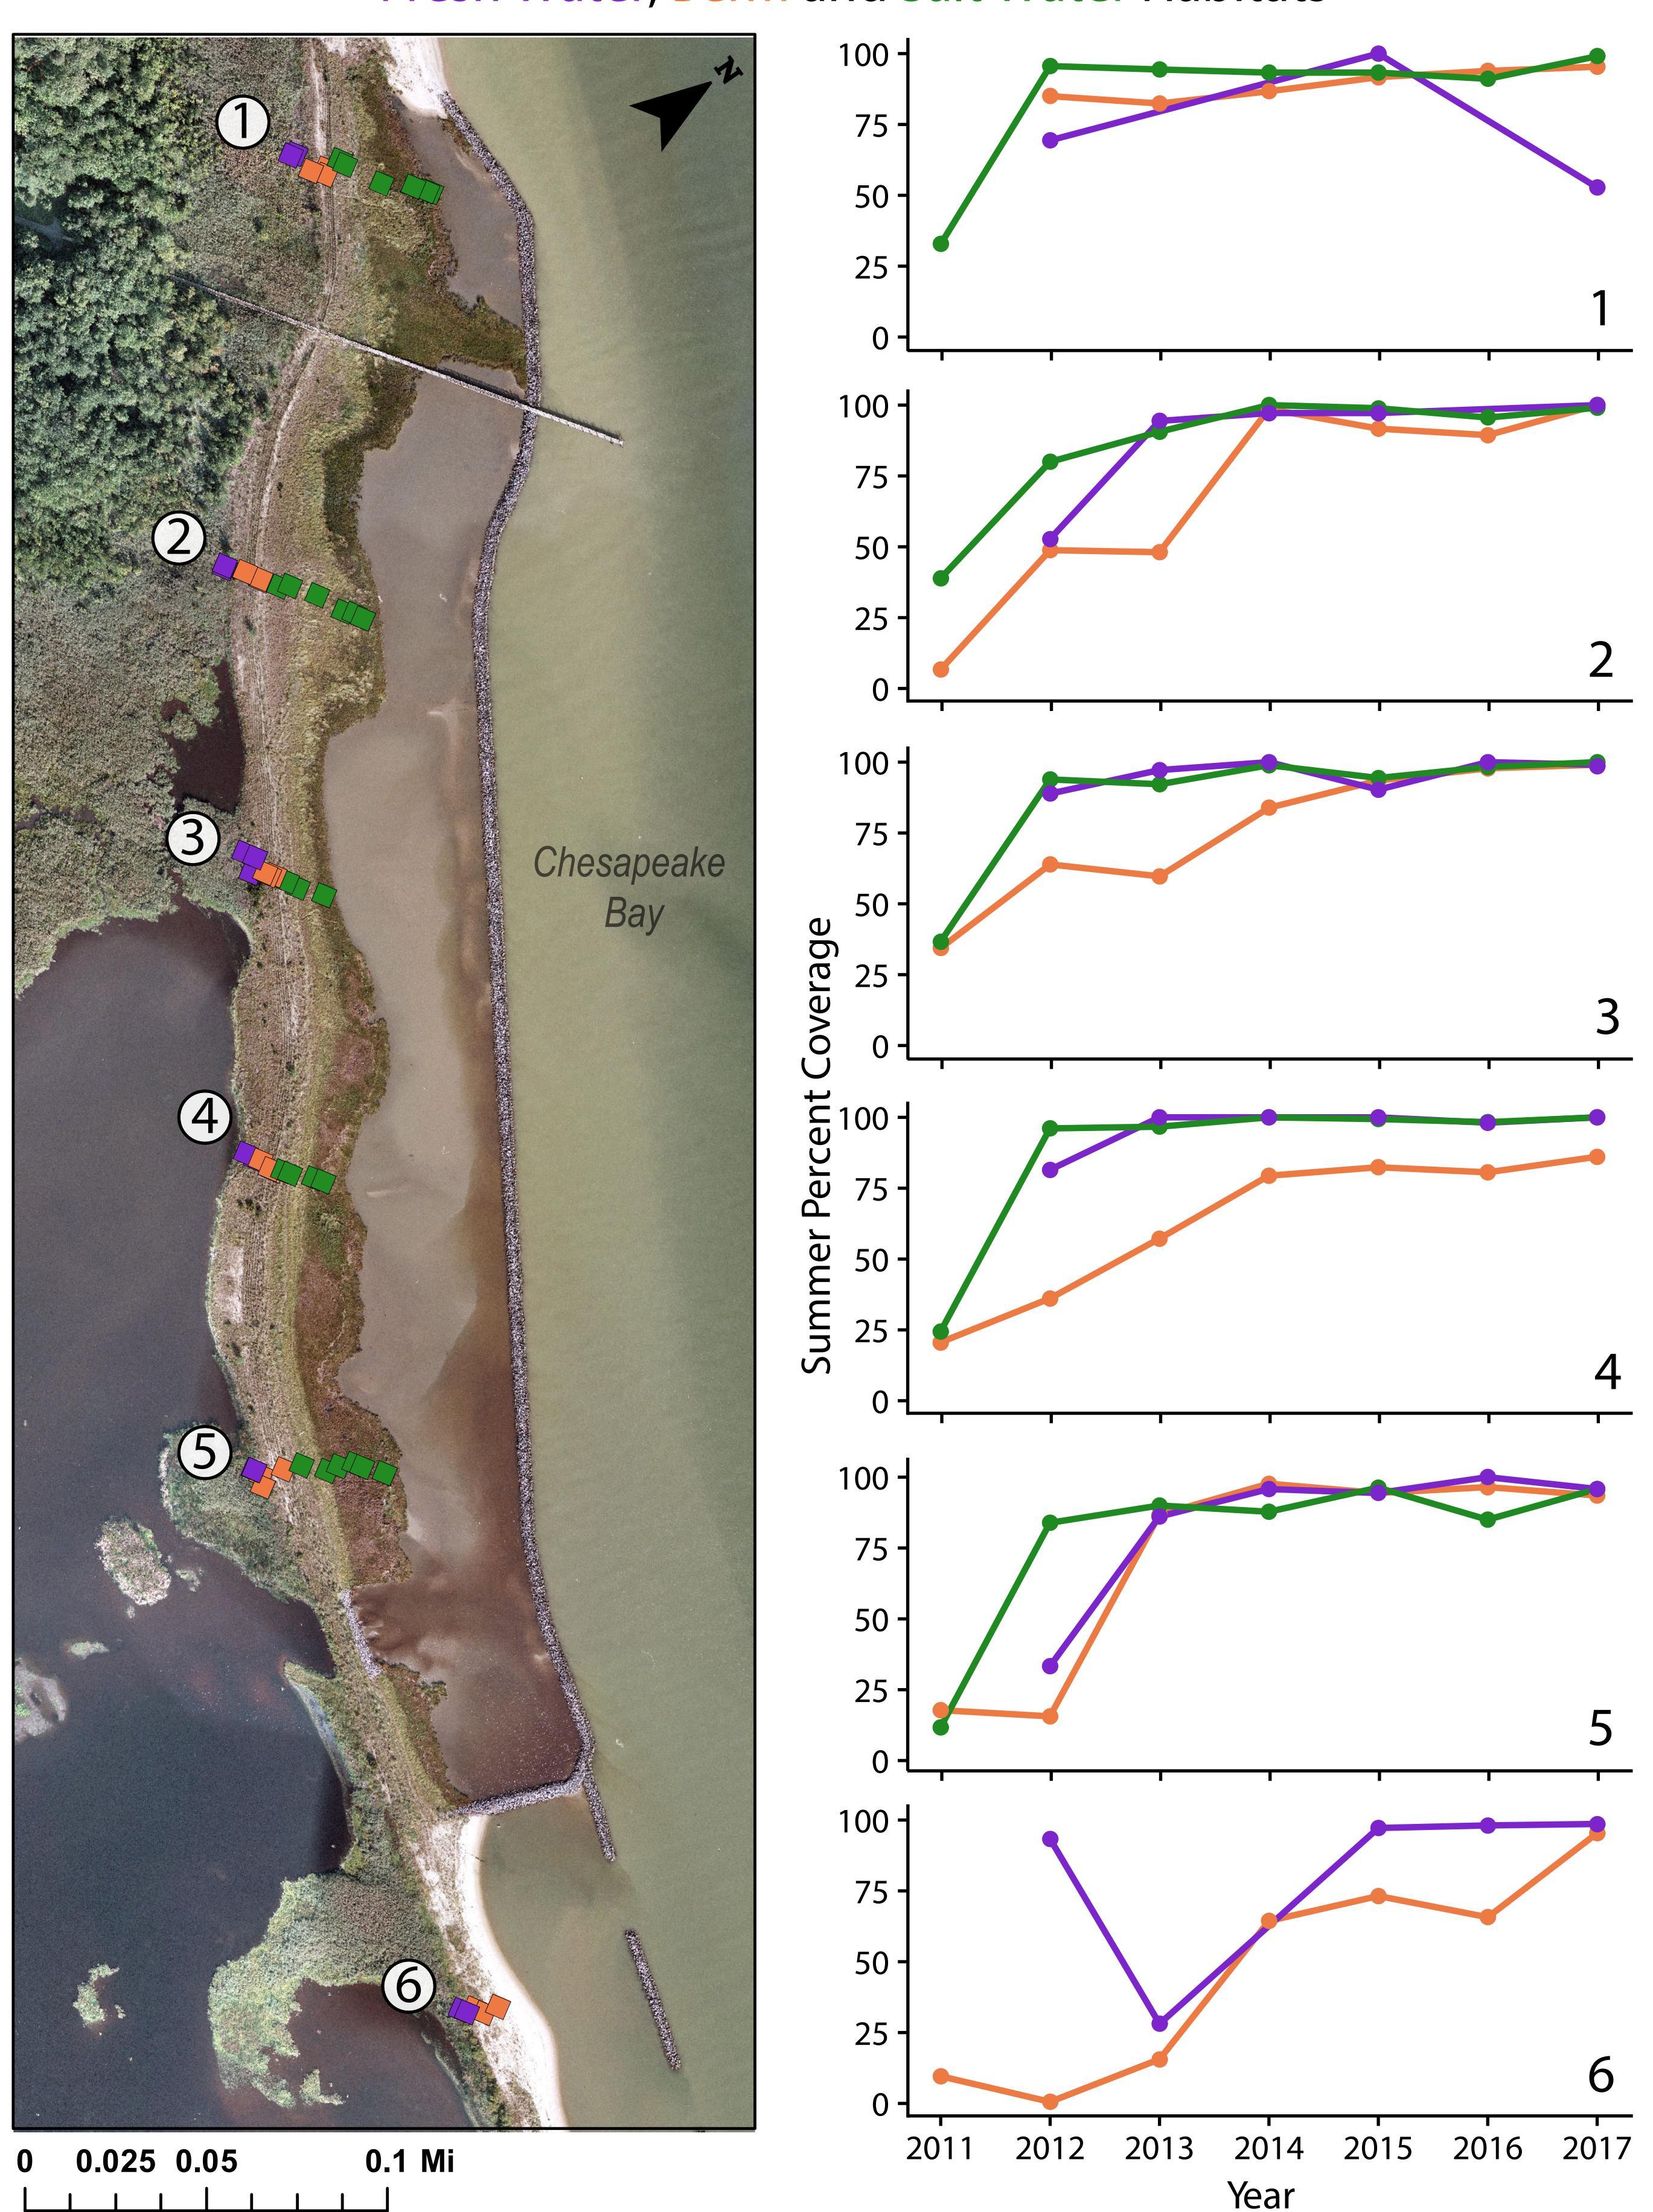
Summer plant percent coverage after planting in Fresh Water, Berm and Salt Water Habitats

Six transects were established to track plant establishment after the restoration. Most have reached equilibrium with a percent cover greater than 75%.

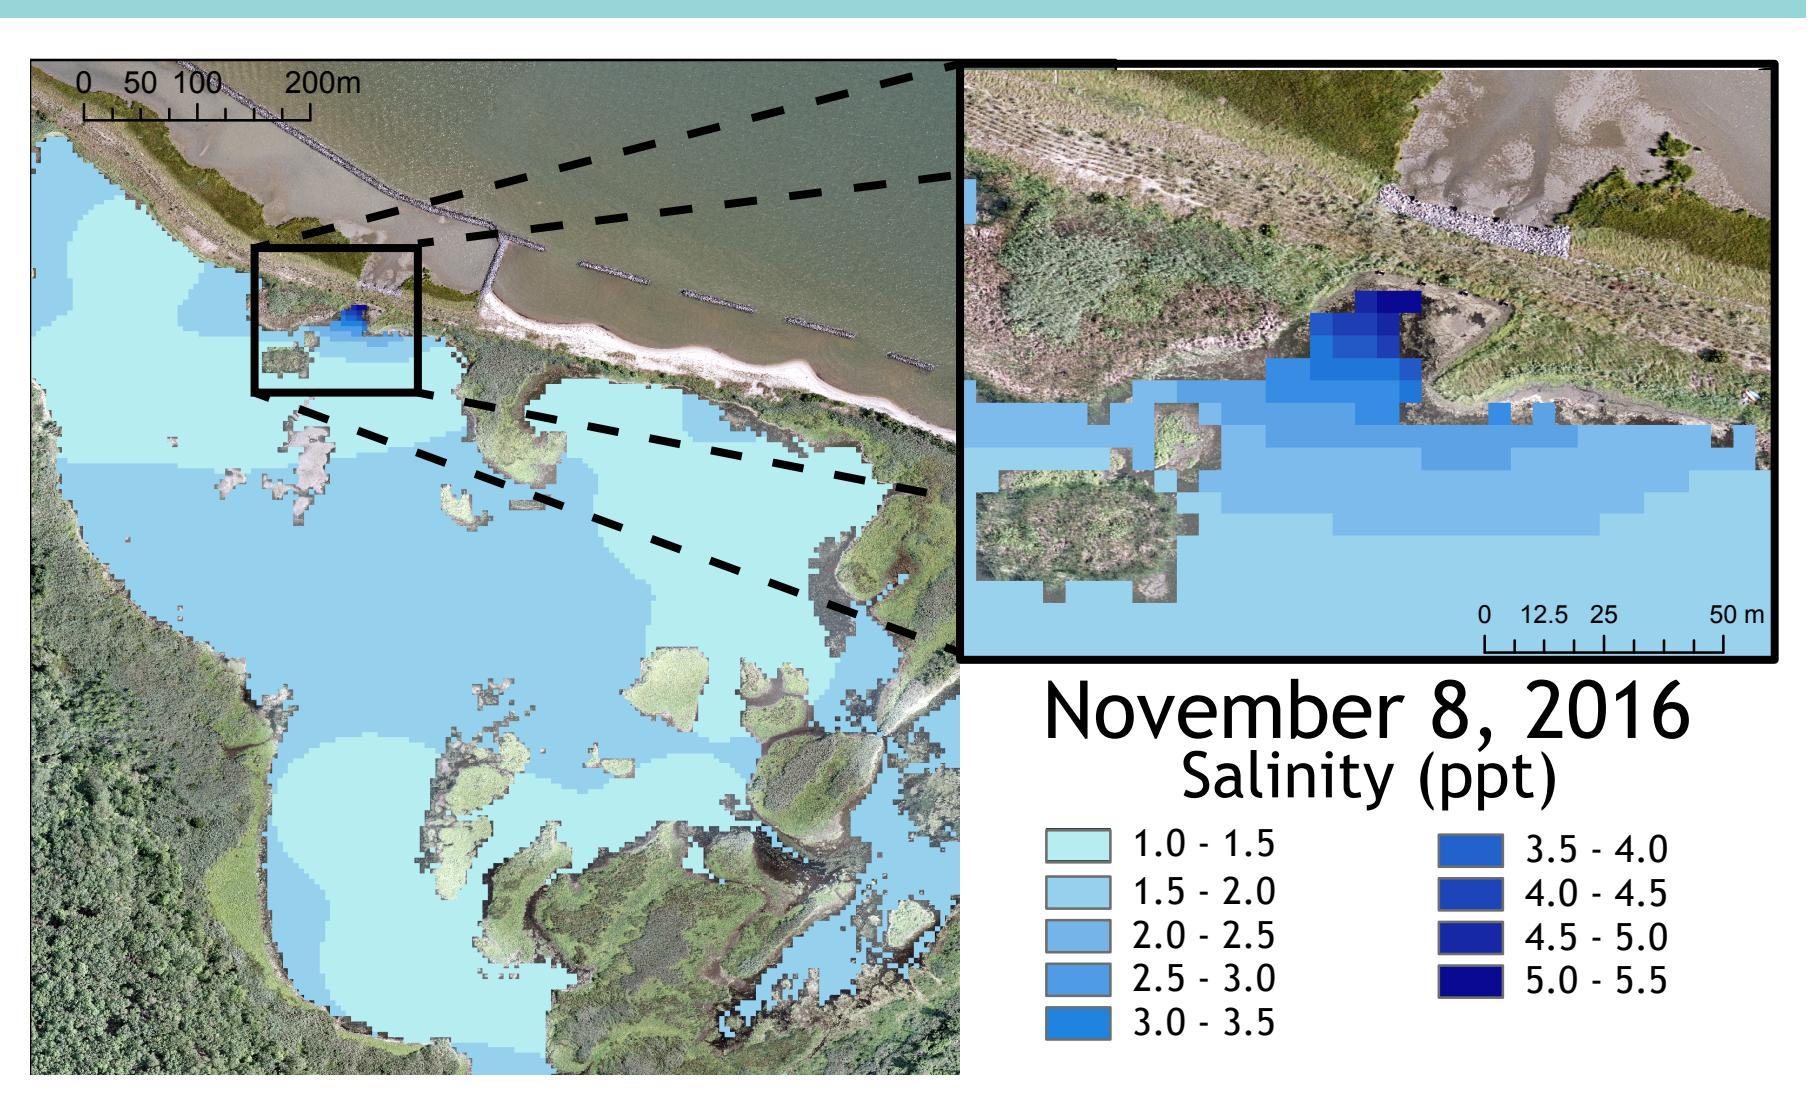
Through kayak surveys, a distinct salinity gradient was observed from the valves that allow water to leave the pond. We determined that there was a faulty valve that allowed bay water into the marsh at high tide. Valves were replaced in December 2016 and the spatial variability of salinities has decreased since then.

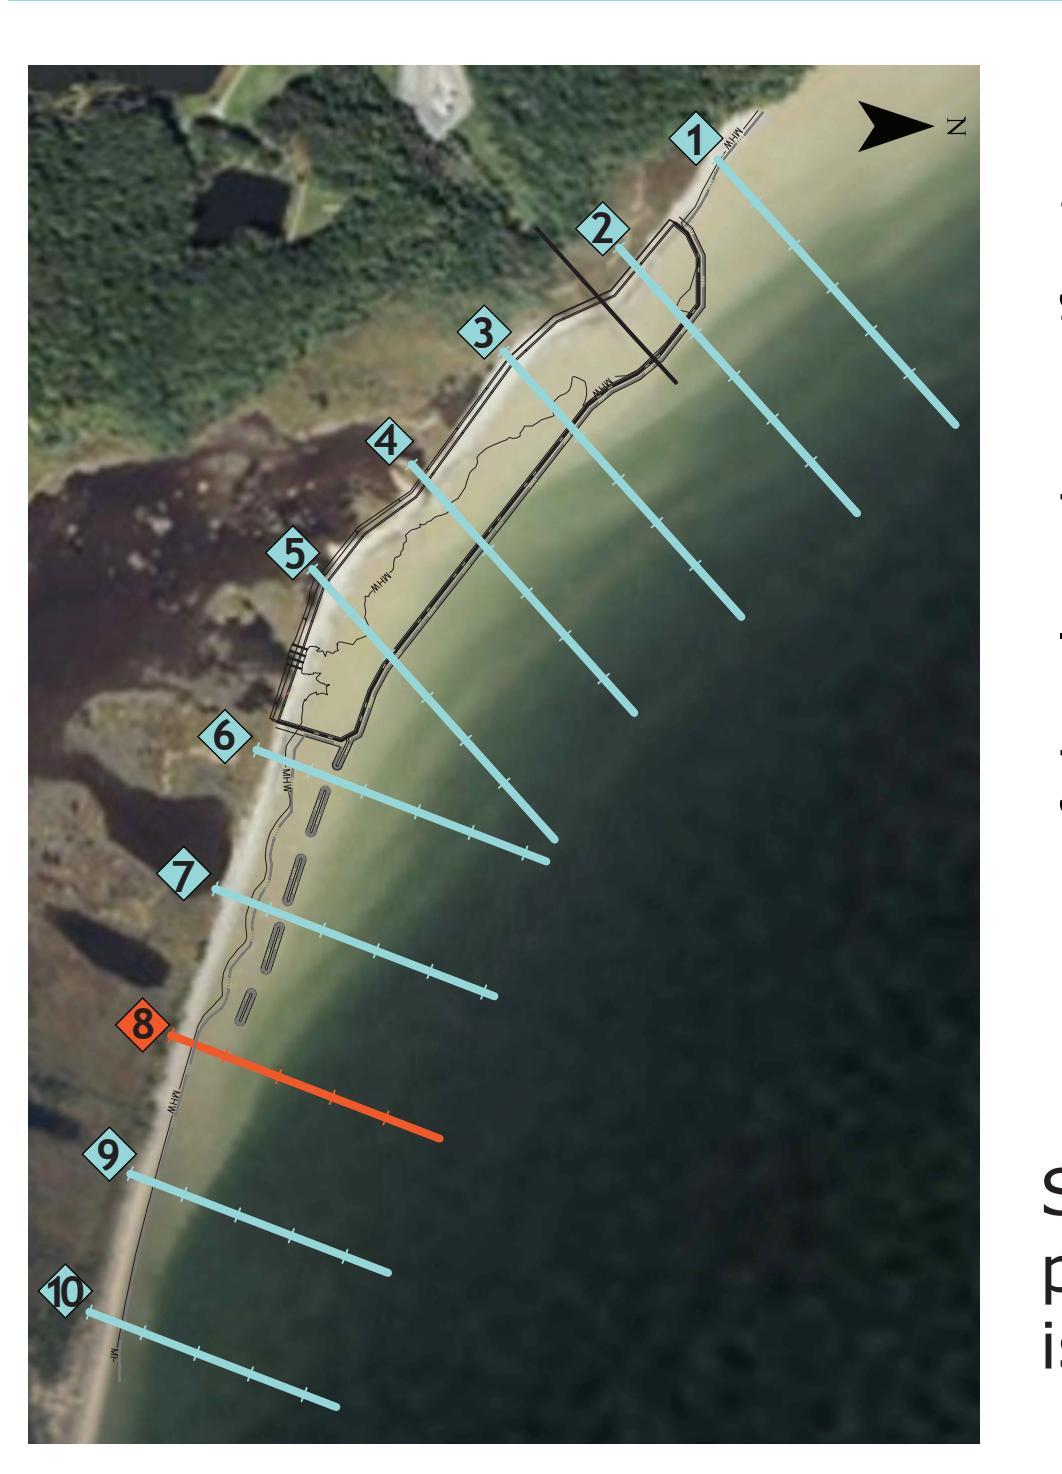
Transects measuring elevation show that restoration success is threatened by erosion south of the breakwaters.

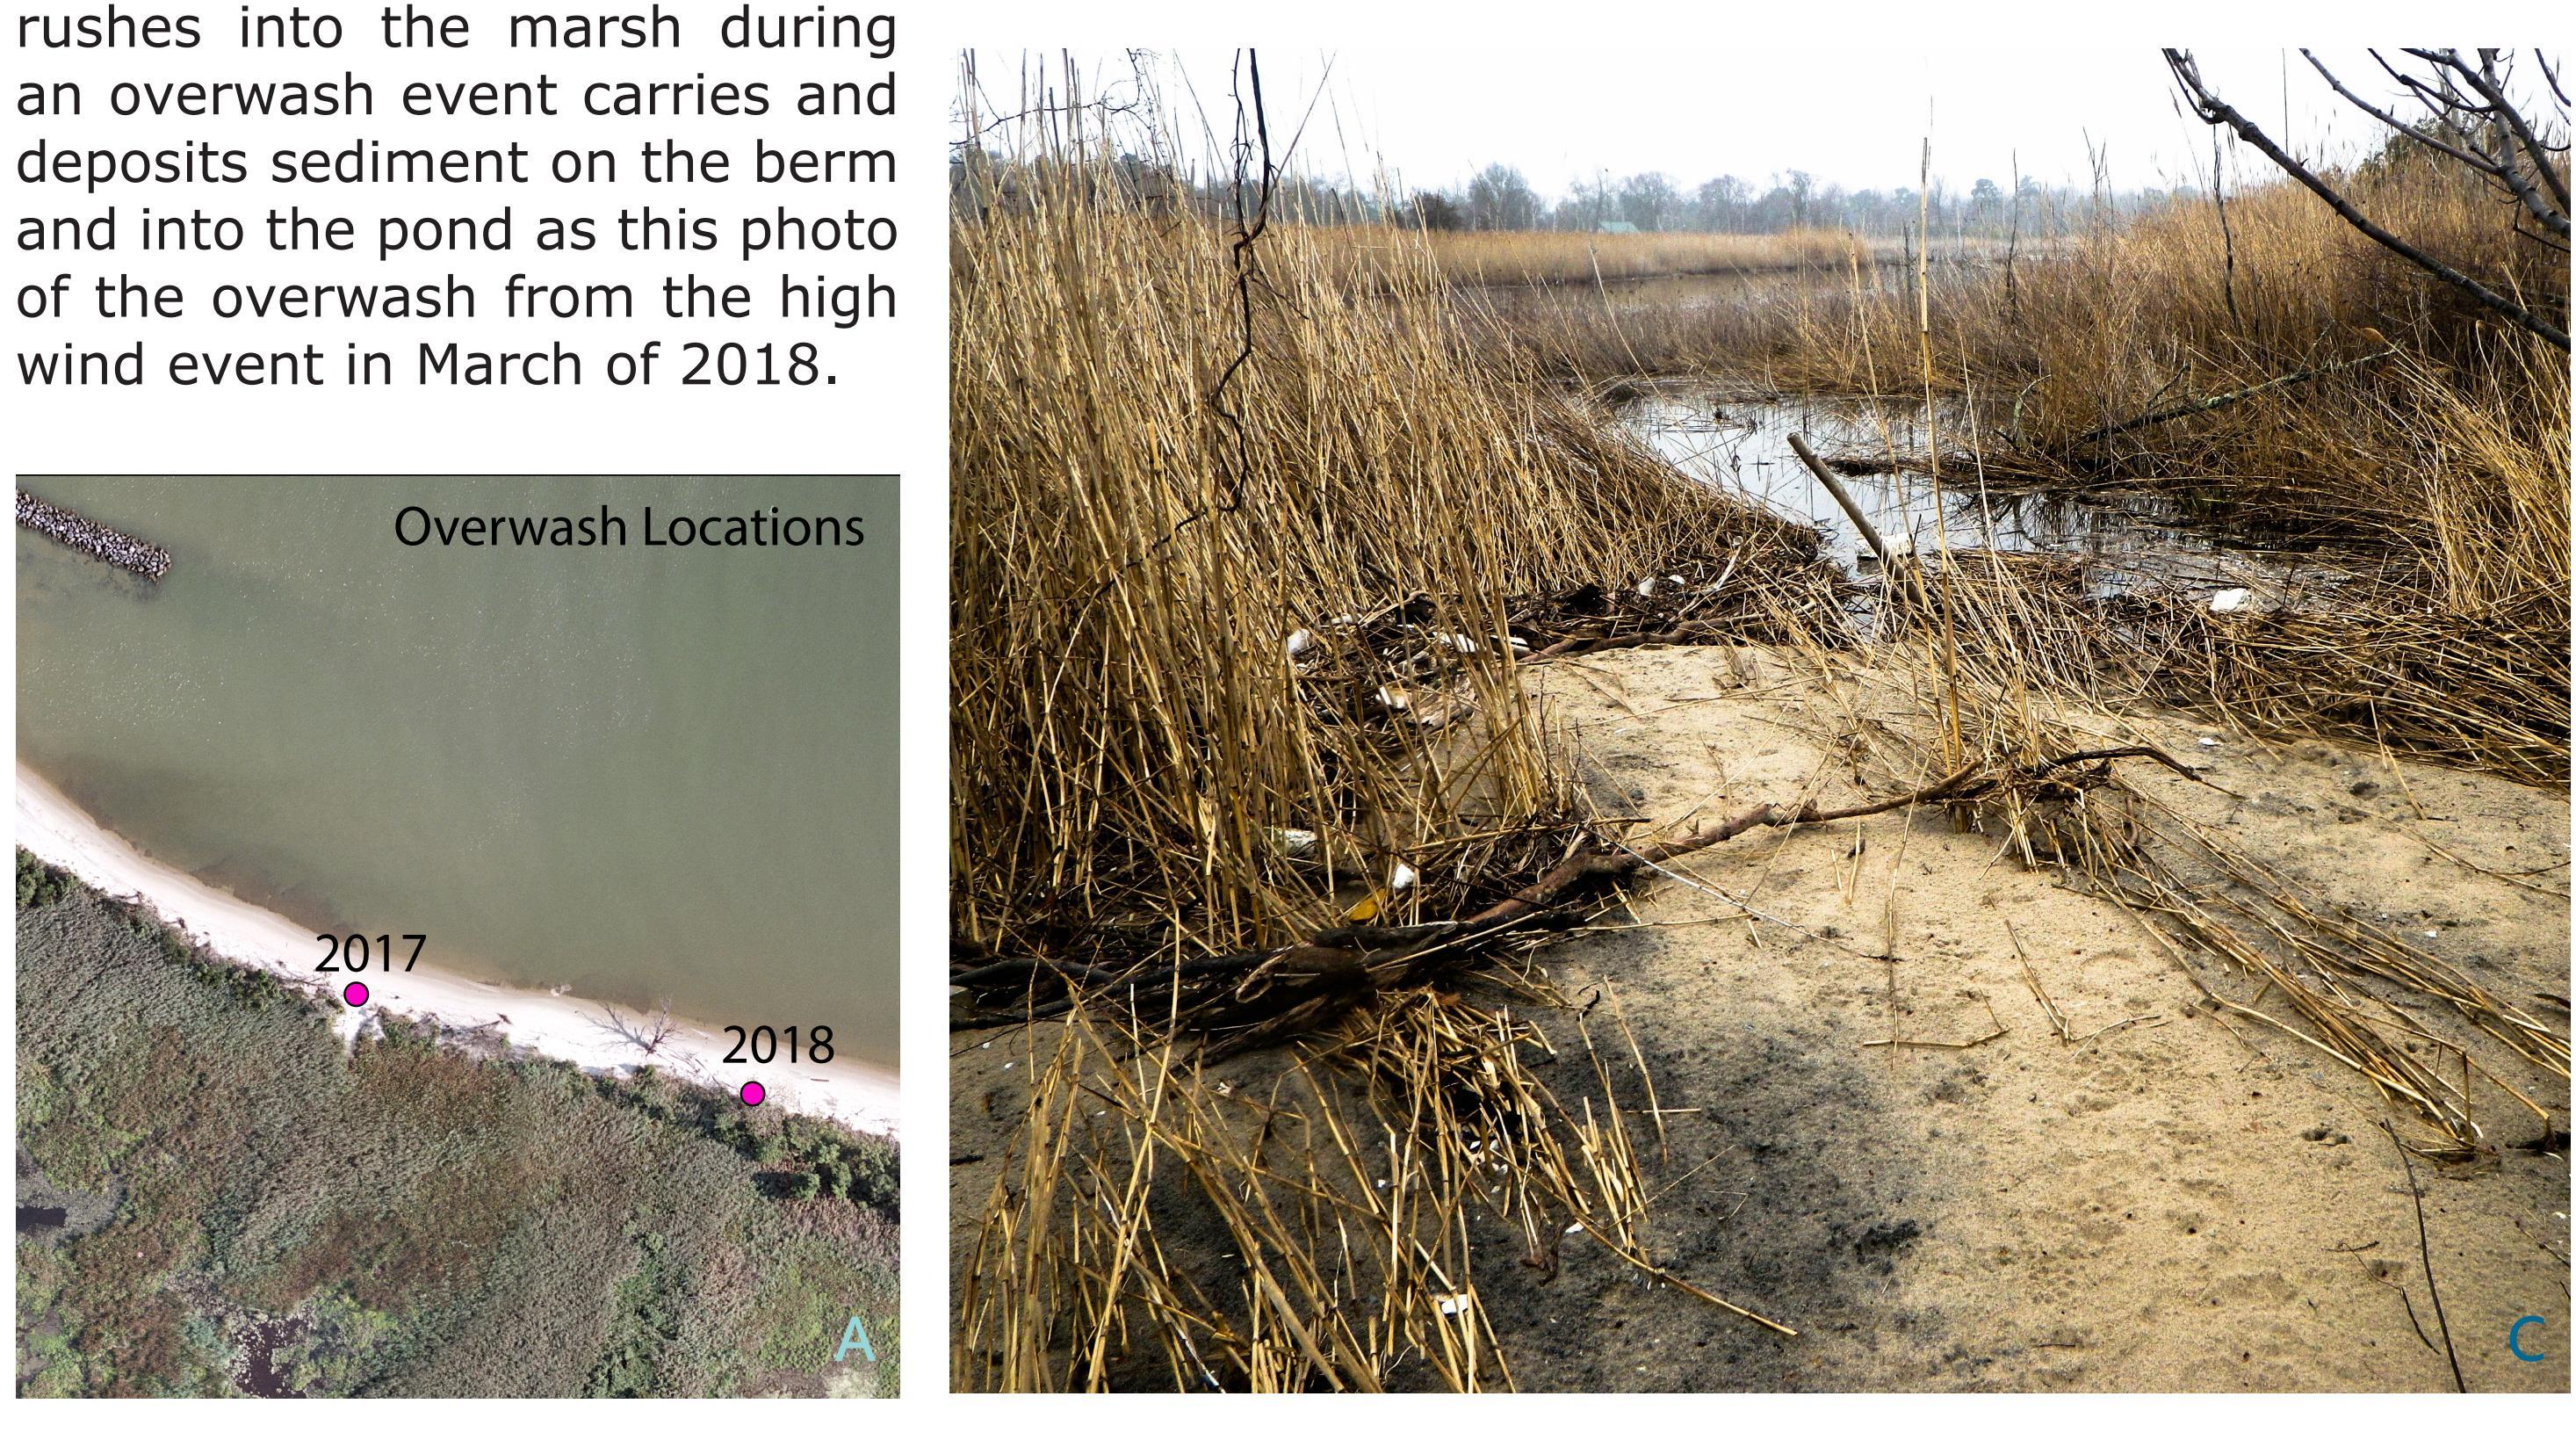
A) Location of overwash events in 2017 and 2018 were southeast of the last breakwater near Line 8 where we are seeing higher rates of erosion.

B) These overwash events take place when there are storms or extremely high water events such as the high water that occured after sustained high winds in March of 2018.

C) The salty baywater that rushes into the marsh during
